Subject: Recommendations for MAC Action:

Subject: Quercus Ilex on Kanan Road, Oak Park

QUERCUS ILEX STUDY AREA

KANAN ROAD, OAK PARK

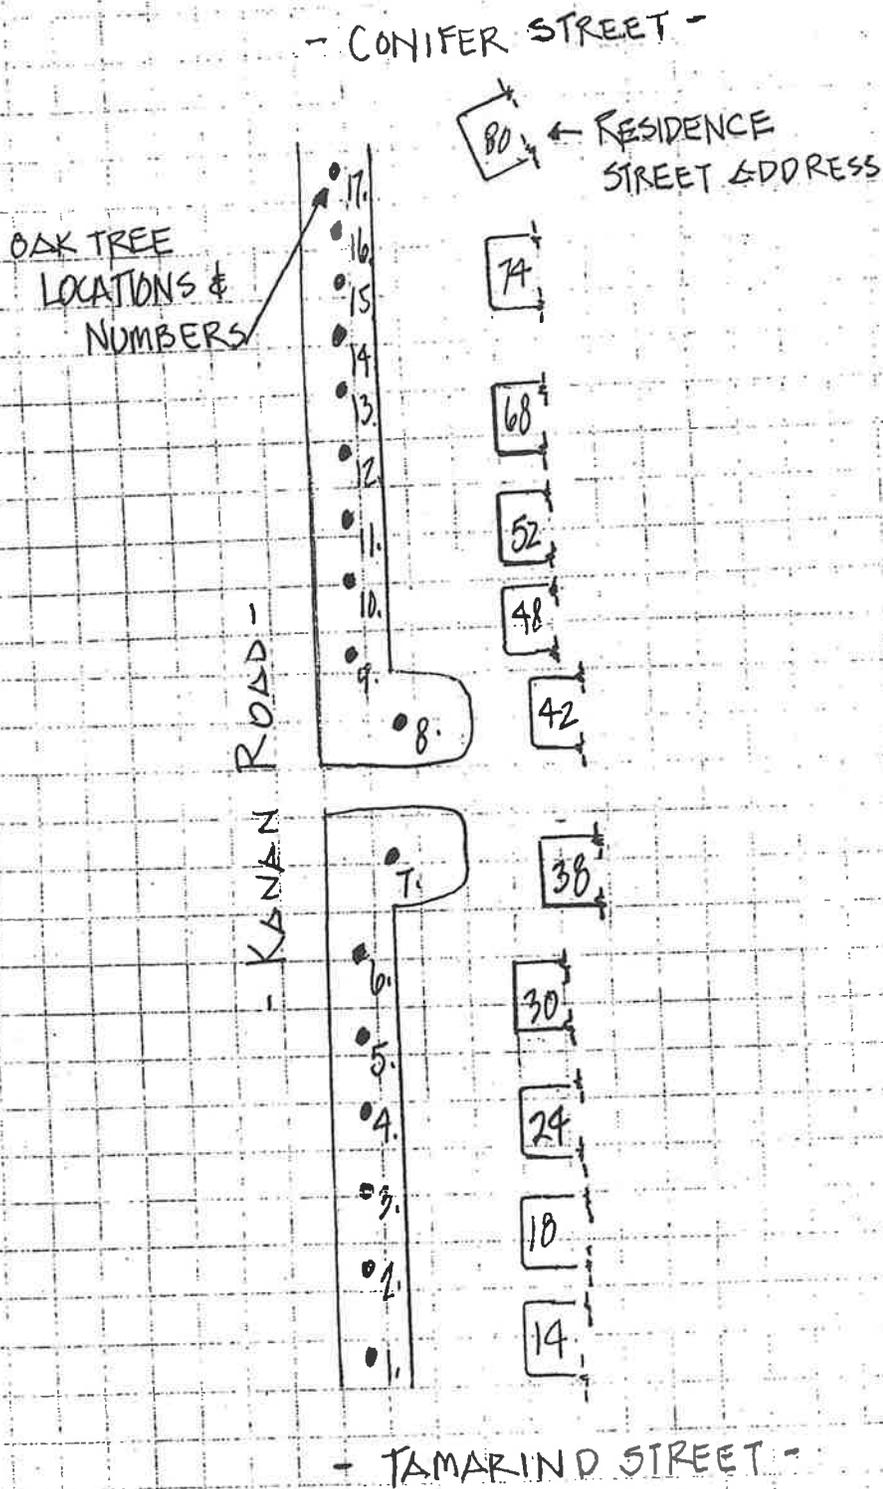
Four (4) of the trees would be rated excellent, 5 are in good condition and 8 specimens are in fair to poor condition.

Enclosed is a sketch that identifies the approximate tree location and number utilized for discussion purposes herein.

Eight (8) of the trees would be recommended for removal and replacement with new specimens. These include numbers 1, 2, 4, 5, 11, 13, 14 and 15. The condition of these specimens is below acceptable standards and they exhibit numerous defects. The potential for development into desirable trees is extremely low and not worthy of generating expenditures and time toward rehabilitation. All of these trees have sparse foliage, dieback and cavities are present in trees number 5, 11 and 15. Number 13 leans.

All of the trees should have the mulched area extended 5' past the canopy dripline. The current mulched area under the trees is inadequate. It would be recommended that the entire parkway turf be eliminated and consideration be given to planting low water use shrub masses. This could be aesthetically pleasing and would only require minor modification of the existing irrigation system. The existing irrigation could also be converted to

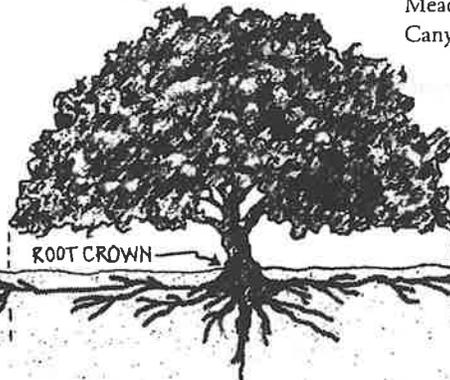
ROOT PROTECTION ZONE

The most crucial area is within six feet of the trunk. Do not irrigate, plant, or disturb the soil in this area.

The root protection zone (RPZ) is 1.5 times larger than the area from the trunk to the dripline. Minimize disturbance, irrigation, and planting in this area.
